**State of Louisiana  
Department of Natural Resources  
Coastal Restoration Division and  
Coastal Engineering Division**

**2005 Operations, Maintenance,  
and Monitoring Report**

**Sabine Refuge Protection**

State Project Number CS-18  
Priority Project List 1

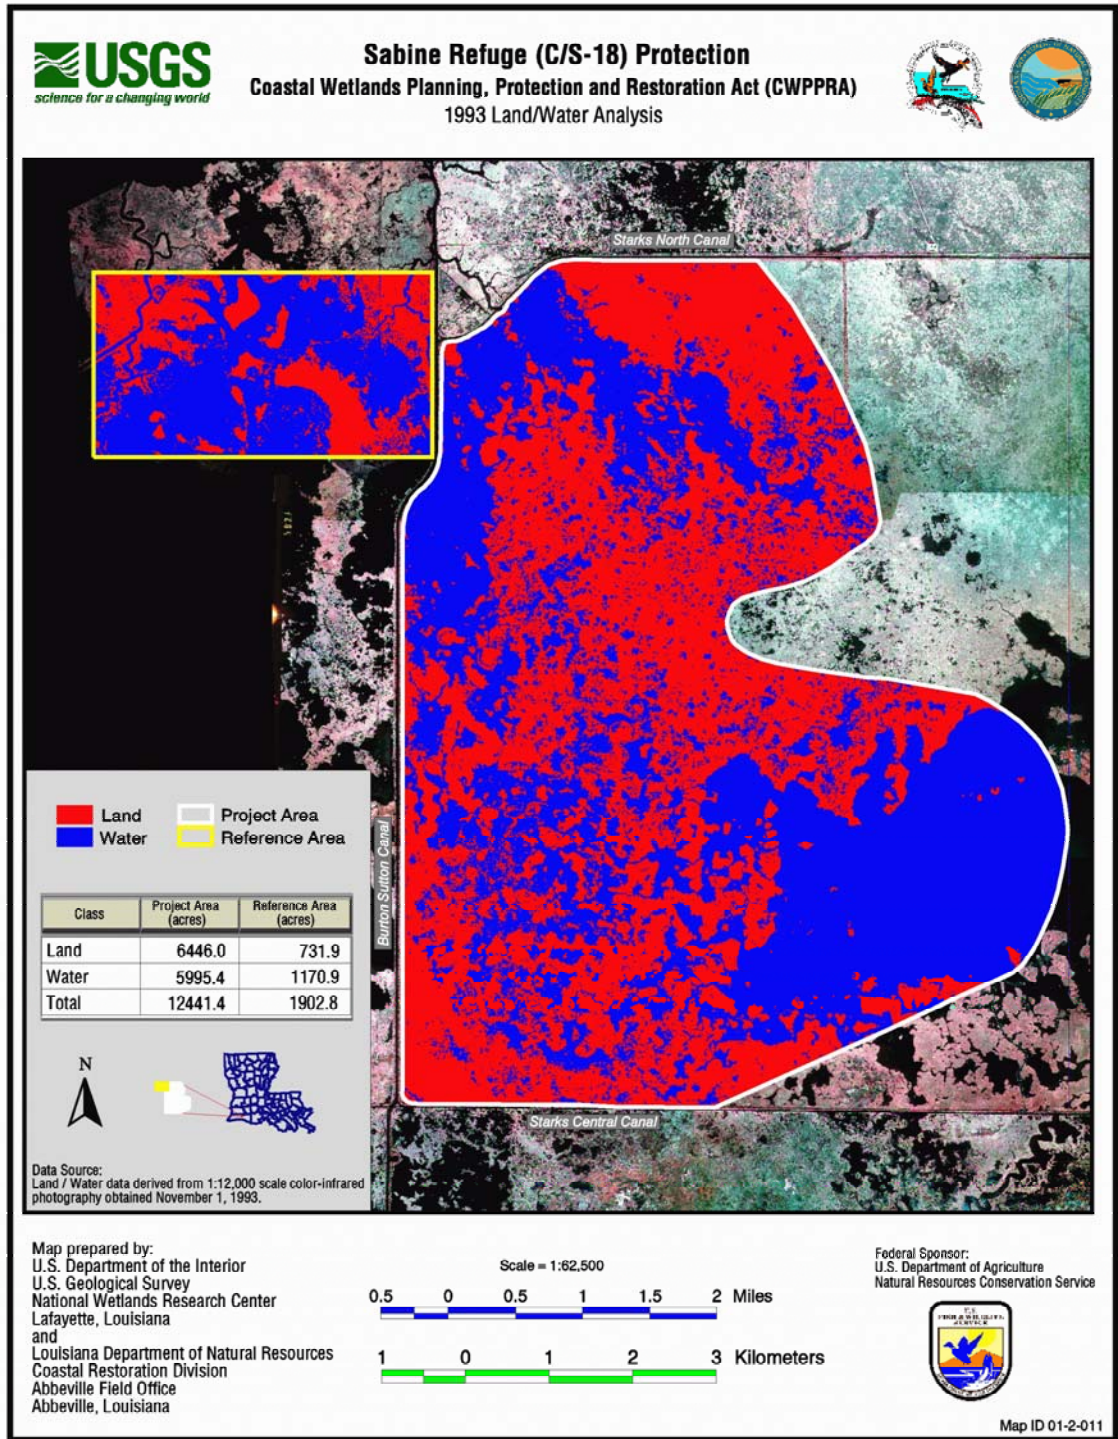
Land to water ratios in the project area were 51.8% land to 48.2% water pre-construction in 1993 and 45.9% land to 54.1% water in 1997 post-construction. In the reference area in 1993, ratios were 38.5% land to 61.5% water and in 1997, ratios were 37.9% land to 62.1% water. It was determined that the 1997 post-construction aerial photography was flown when water levels in Impoundment 3 were much higher than during pre-construction photography (1993). Because the reference area is not impounded, water levels were lower than in the impoundment, and land to water ratios did not reflect those in the project area. The land loss in Impoundment 3 (figures 2 and 3) is not as high as it appears. Field observations suggest that little or no land loss has occurred.

**Figure 2.** Sabine Refuge Protection (CS-18) GIS analysis of project and reference area pre-construction aerial photography (1993).

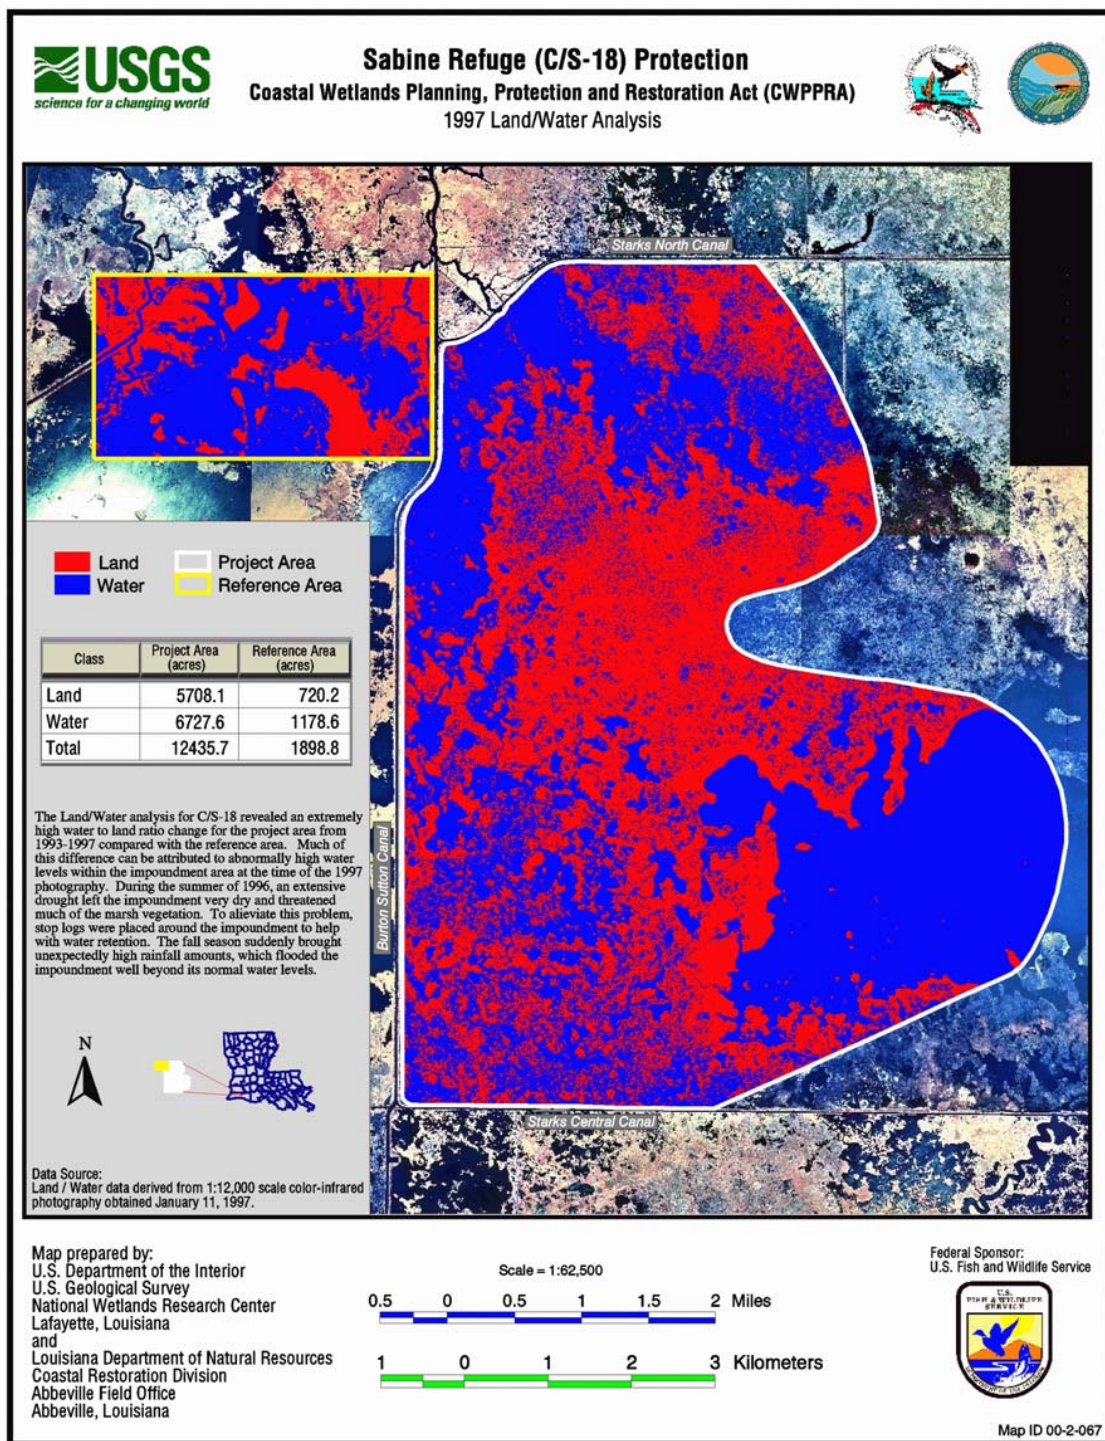
**Figure 3.** Sabine Refuge Protection (CS-18) GIS analysis of project and reference area post-construction aerial photography (1997).

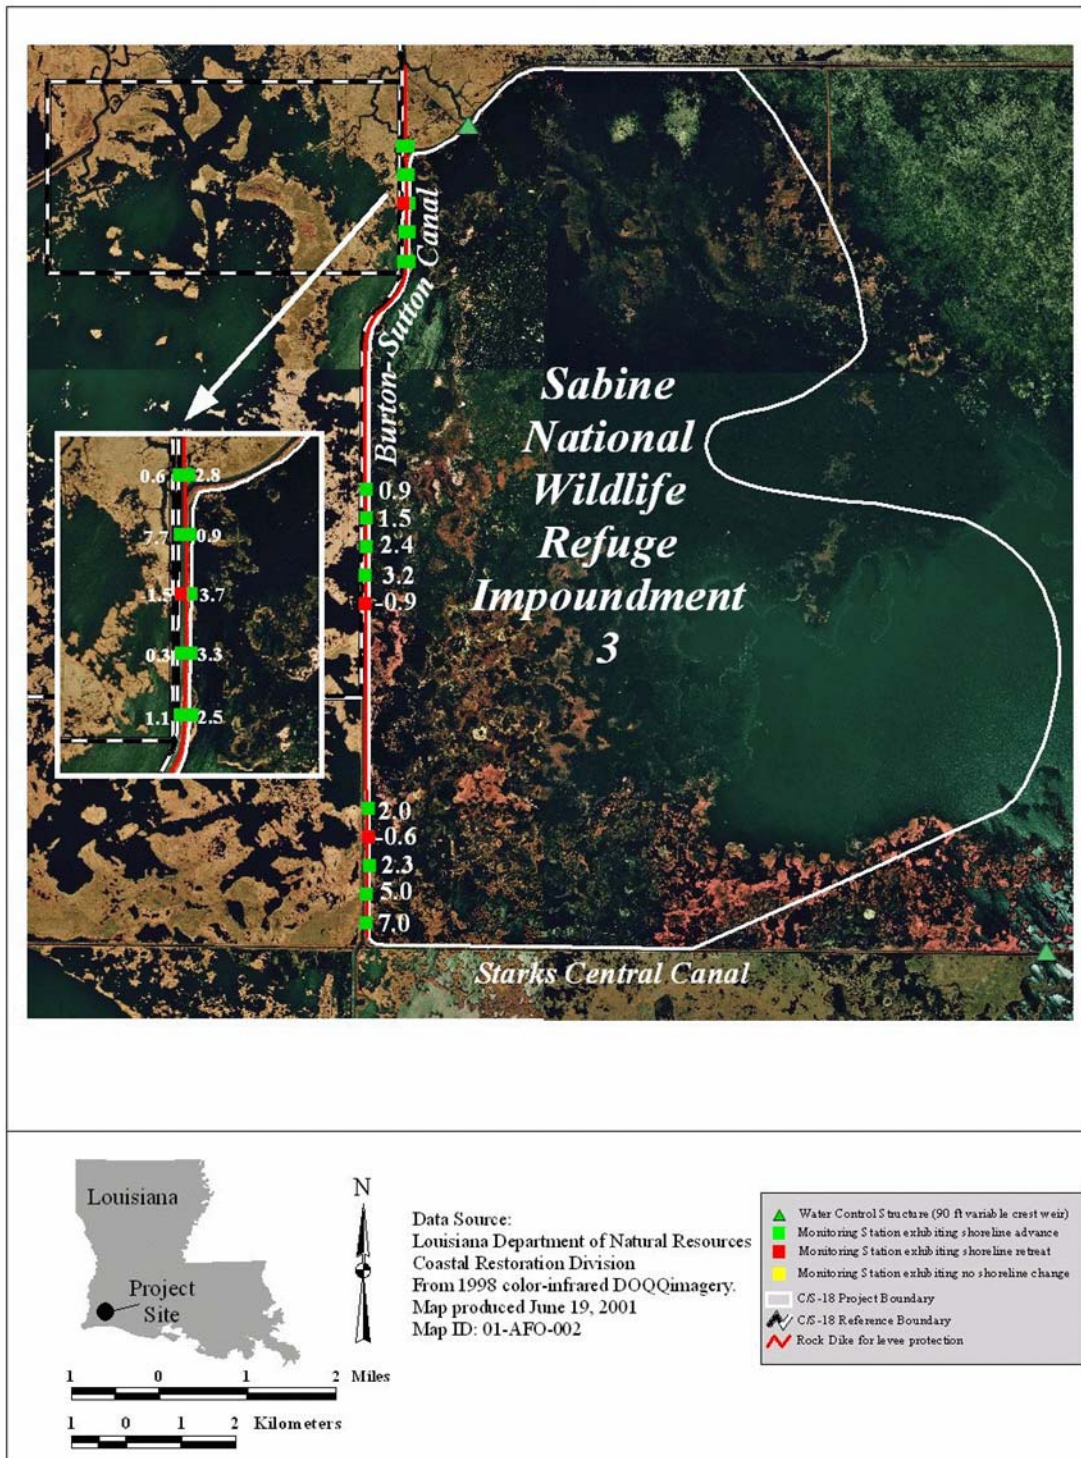
Shoreline survey results, presented in figure 4, show shoreline position change during the study period differing by less than 7.8 ft (2.4 m) at any one station for both the project and reference areas. Shoreline advance was detected at all project stations except stations 30 and 112 and for all reference stations except 252R during the period between 1995 and 2000 (figure 5). Mean shoreline advance rates were calculated to be  $1.3 \pm 1.1$  ft/yr ( $0.4 \pm 0.3$  m/yr) and  $0.9 \pm 1.9$  ft/yr ( $0.3 \pm 0.6$  m/yr) for the project and reference areas, respectively. The results of the two-sample t-test indicated that there was no significant difference in shoreline change rate detected between the project and reference areas ( $P = 0.90$ ).

**Figure 4.** Sabine Refuge Protection (CS-18) shoreline change (ft) at project and reference area monitoring station locations between October 1995 and August 2000.

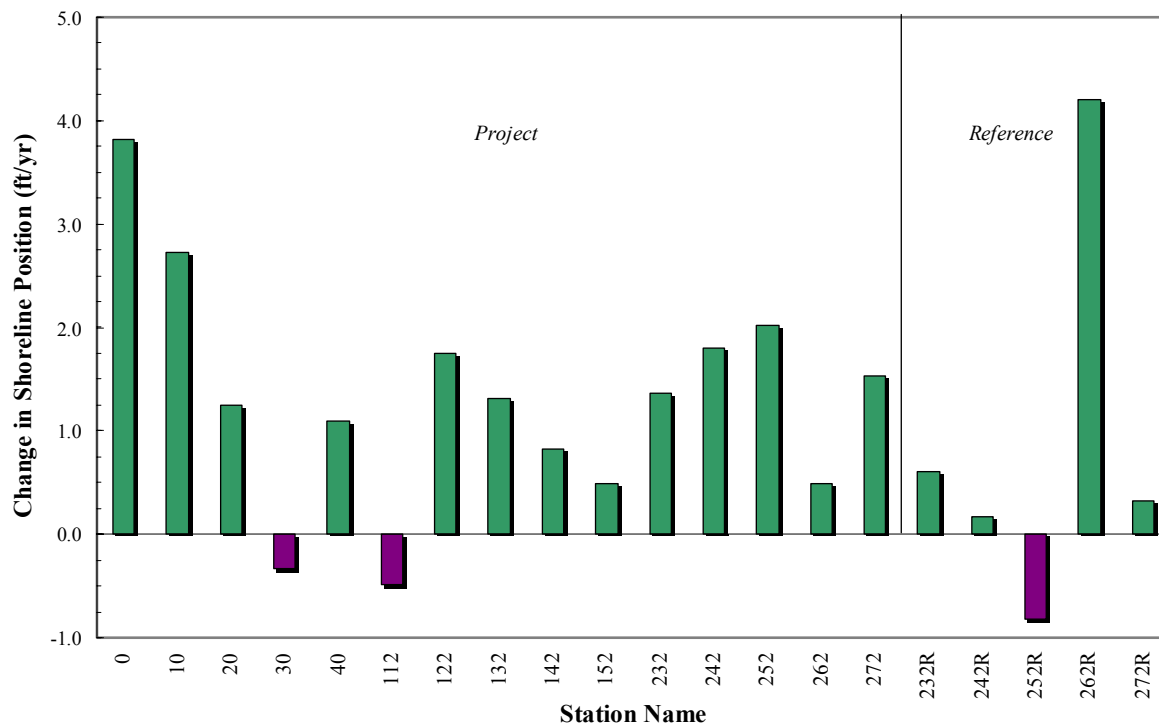
**Figure 5.** Sabine Refuge Protection (CS-18) shoreline change for the project and reference area from 1995 to 2000. Rates are calculated in ft/yr.

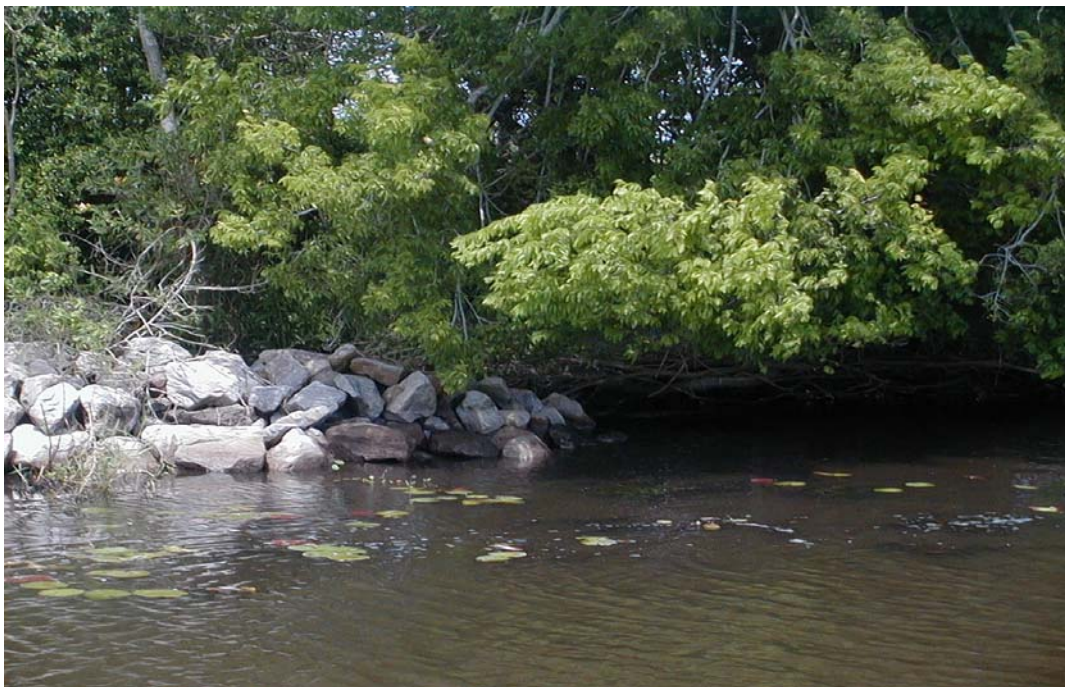
The dikes are in excellent post construction condition. No need for any maintenance in the foreseeable future. (Photos: Appendix A, Photos 1–2.)

Photo 1—southern tie-in on the Burton-Sutton Canal

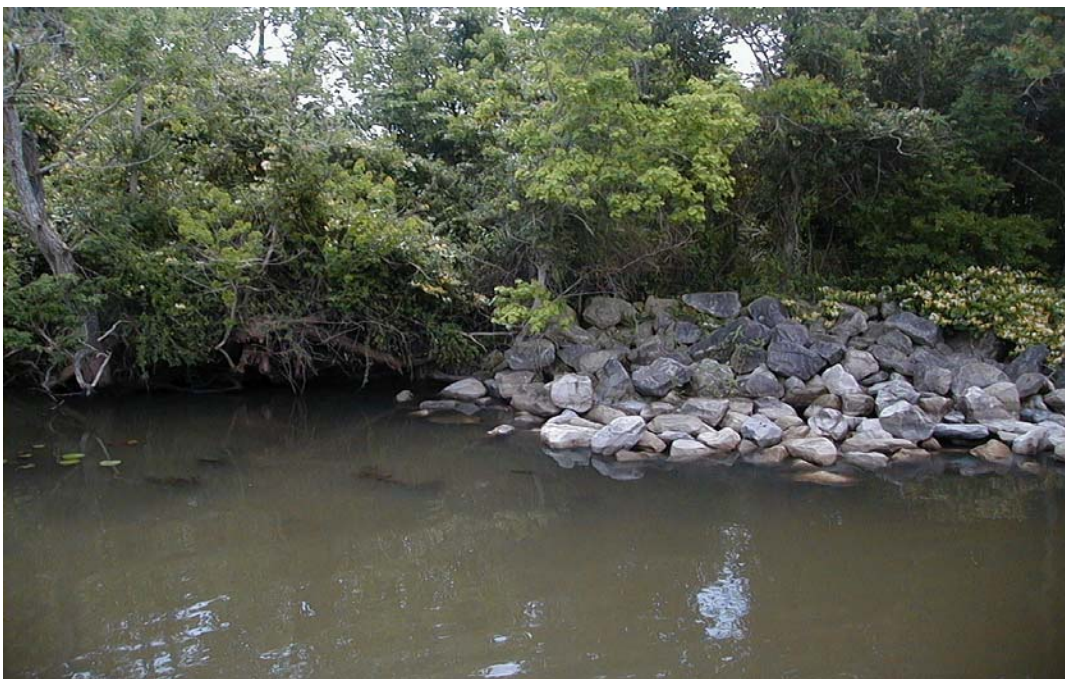
Photo 2—northern tie-in

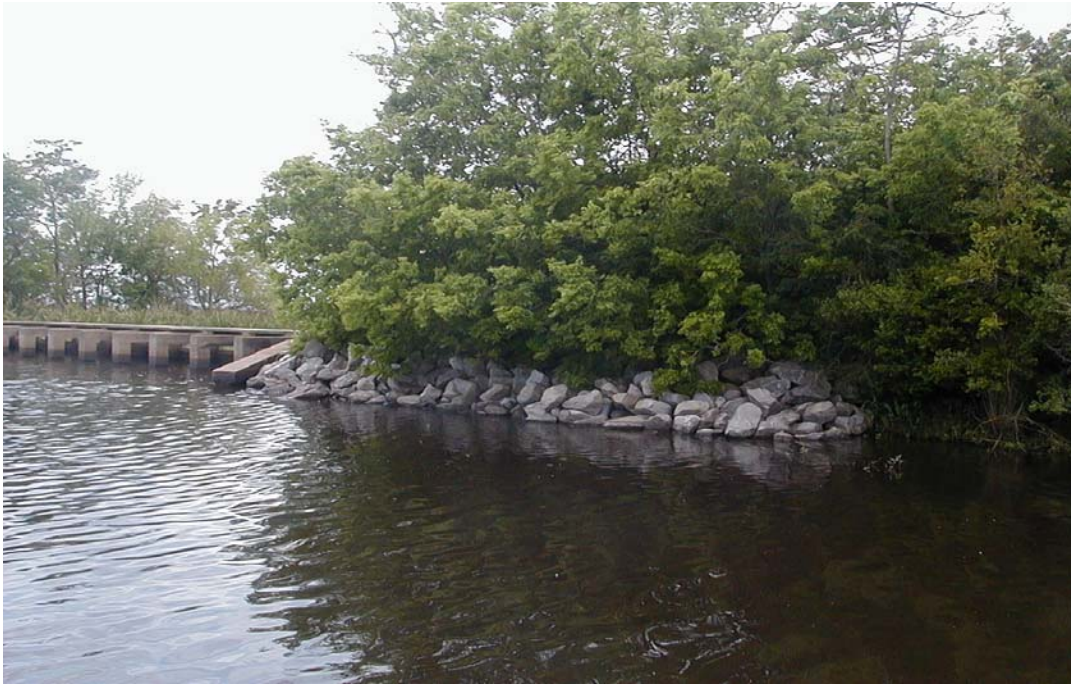
Excellent condition. No maintenance required at this time. (Photos: Appendix A, Photos 3-4.)

Photo 3—wingwall rock on Beach Canal structure

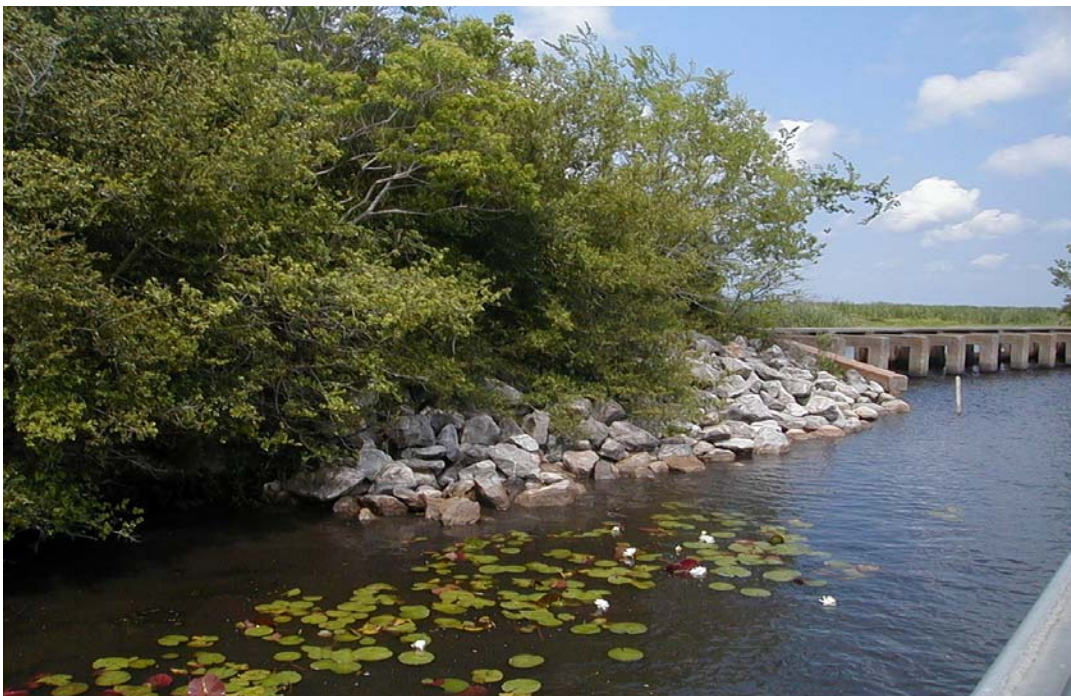
Photo 4—wingwall rock on Starks Central Canal structure
